DOCUMENT 403-92

SYSTEM TRACKING ACCURACY AND OPERATIONAL ACCEPTANCE TESTING OF THE AUTEC SONOBUOY TRACKING SYSTEM (STS)

JULY 1992

UNDERWATER SYSTEMS GROUP RANGE COMMANDERS COUNCIL

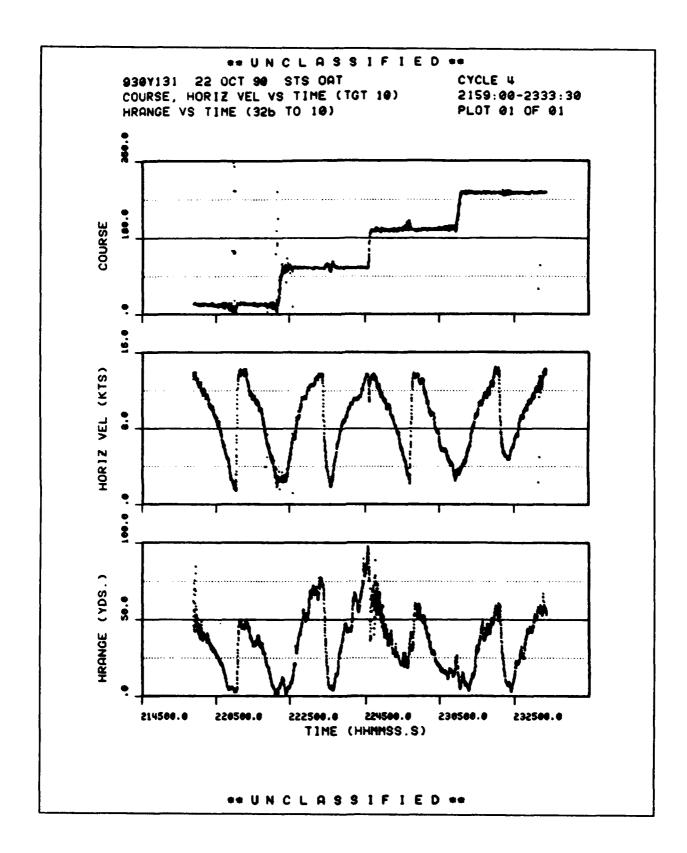
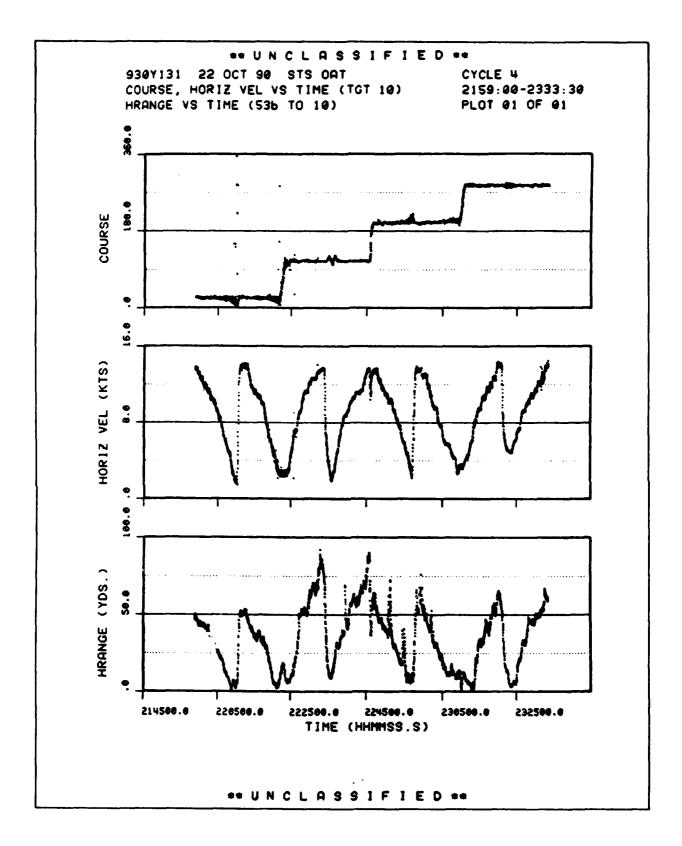
For cycle 4, with only two tracking channels assigned, horizontal position differences between the STS and I/W systems along with boat course and speed, are plotted versus time in figures 33 and 34 (for P1 on channel 32 and P4 on channel 53. As expected with velocity components clipped at ± 2.0 m/s, position errors in STS are highly correlated with speed as they were in the post-SAT test, figures 26a and b. Horizontal position differences between STS-I/W plotted versus speed and course are shown in figures 35 and 36 (for P1 and P4), and are similar to figures 27a and b for the post-SAT test.

Figure 33. OAT, horizontal range versus time, 32, cycle 4.

Figure 34. OAT, horizontal range versus time, 53, cycle 4.

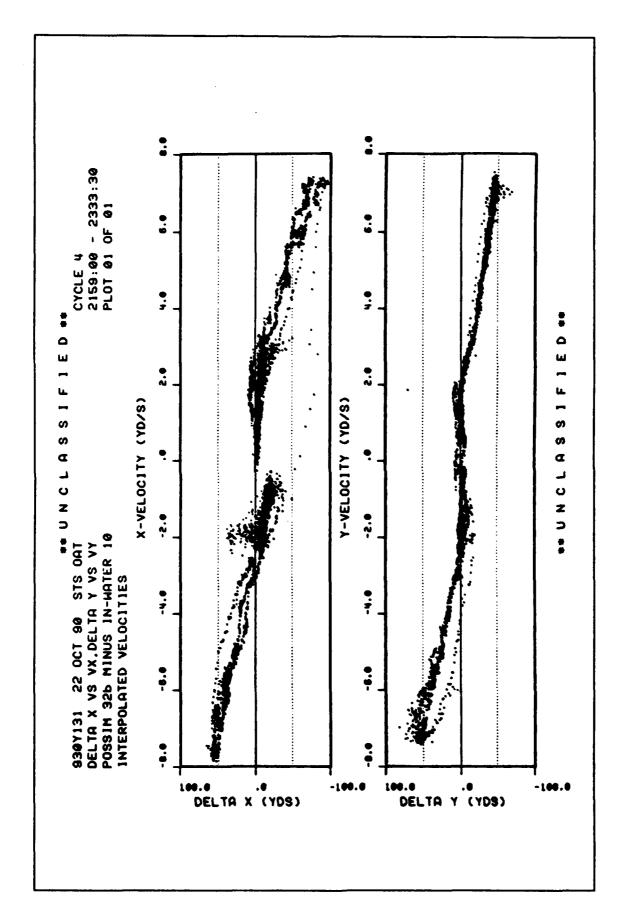
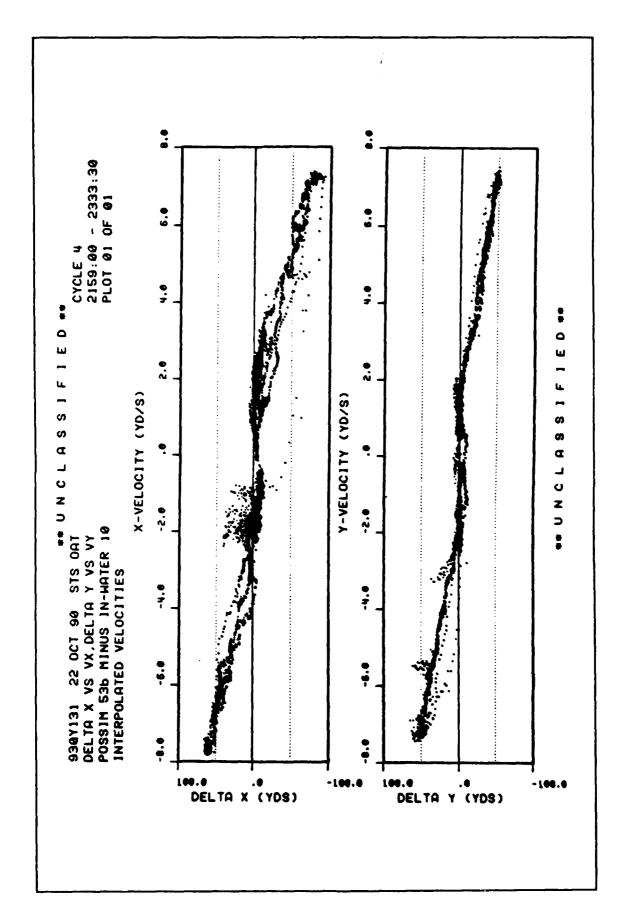
The striking difference between the OAT test results and those from the post-SAT test is shown in figures 37 and 38 (for P1 and P4) versus figures 29a and b. Note that the OAT data reveals a distinct difference in X and Y position errors for speeds between ±2.2 yards/seconds (~2.0 m/s) as opposed to those outside this interval; the post-SAT test did not. (Why the post-SAT data did not reveal this discrepancy, as noted in subparagraph 7.1.2.1, is not known at this time.) Thus, velocity clipping became the likely cause of position errors correlated with time.

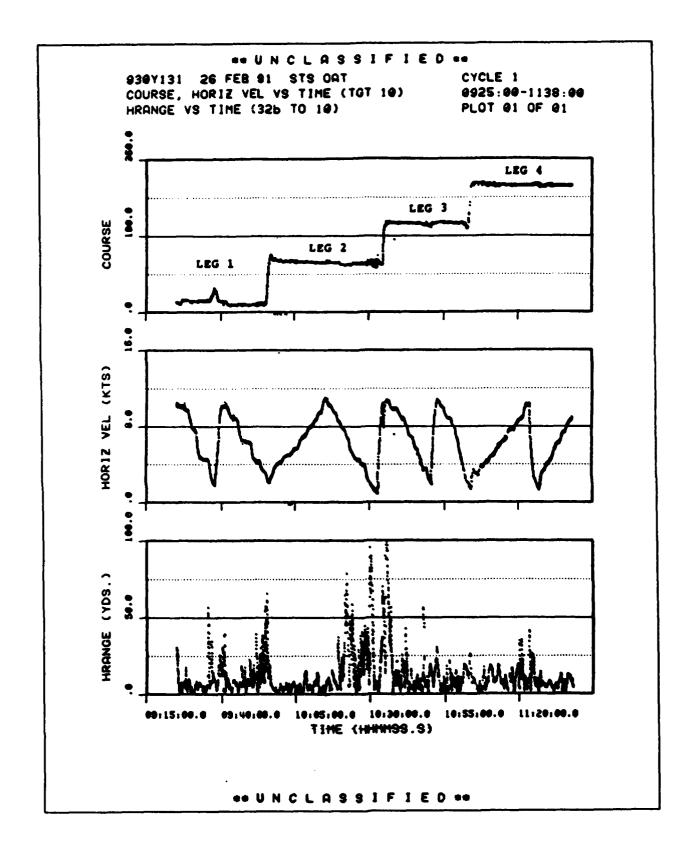
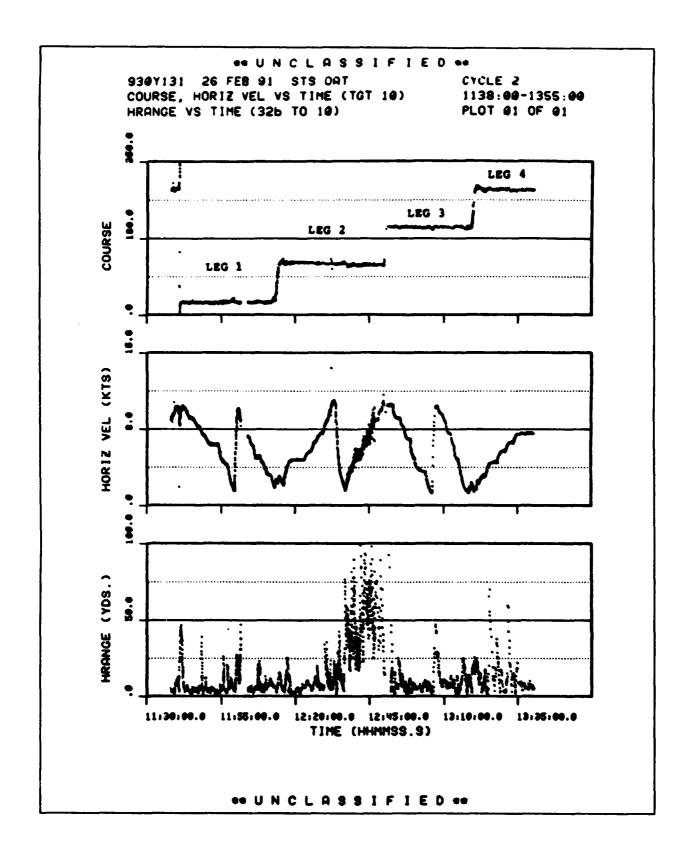
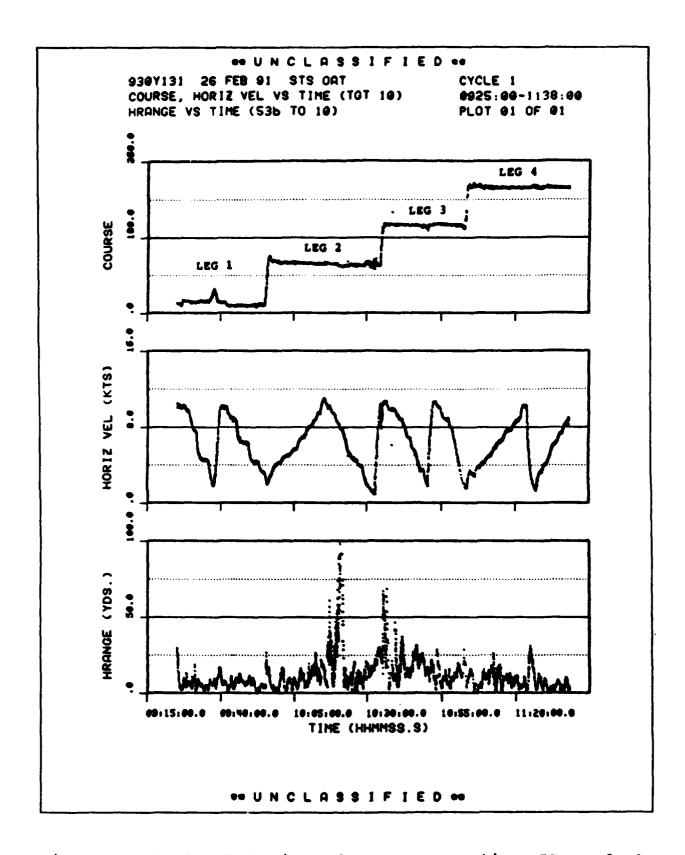
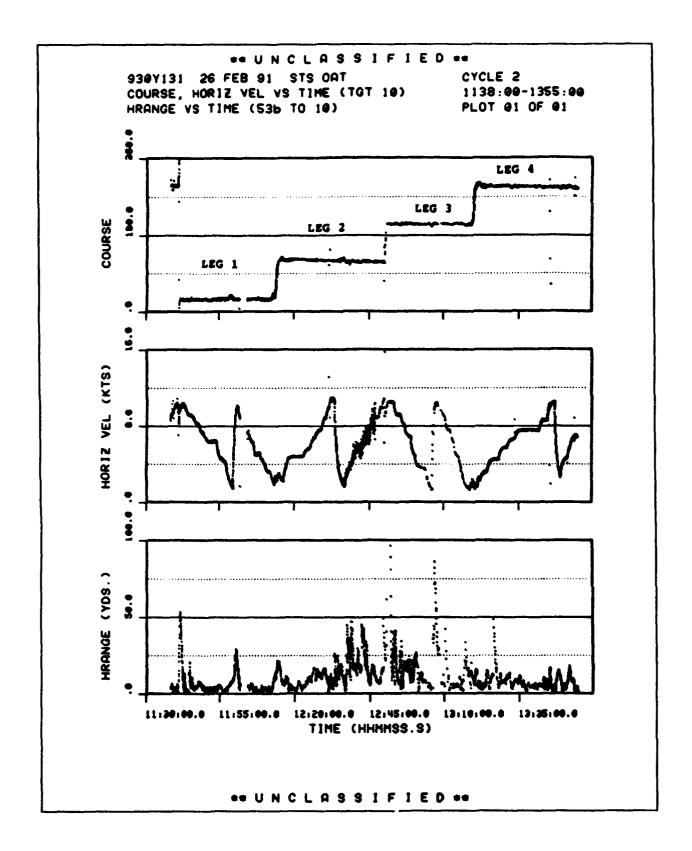
Figures 39 through 42 are plots versus time of course, speed, and horizontal position difference between the STS and I/W systems for both channels 32 and 53 for both cycles. There appears to be no correlation with speed.

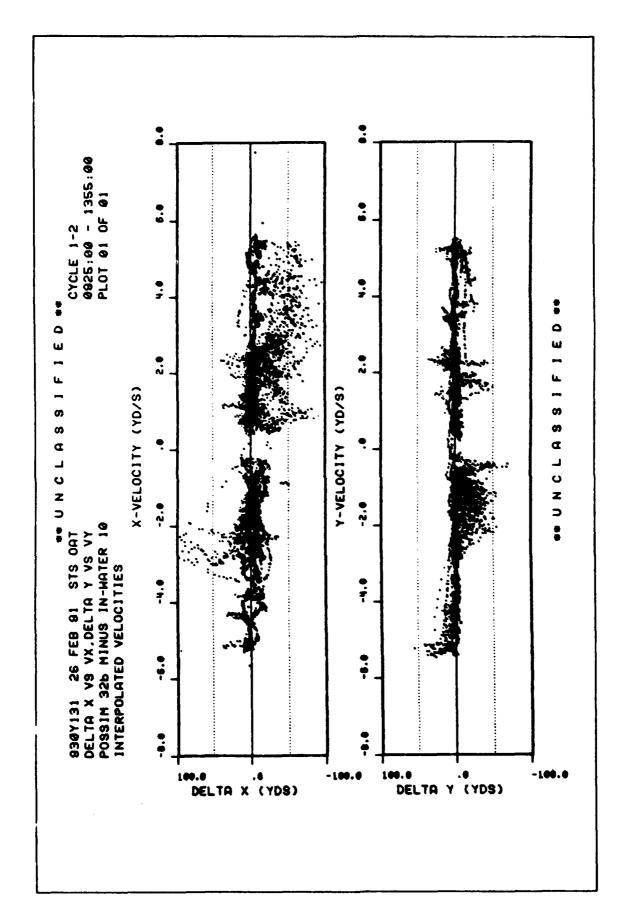
Post-OAT, horizontal range versus velocity and course, 53. Figure 44.

Figures 43 and 44 are plots of horizontal position differences between STS and I/W versus speed and course, and figures 45 and 46 are plots of X and Y position differences versus X and Y components of velocity. These plots confirm no correlation with speed. To aid in comparisons with the previous tests, the following cross-reference of figure numbers is provided.

Curiously, a large noise burst occurs again during the last half of leg 2 during cycle 2 (see figure 40). Noise during similar time periods occurs for channel 53 in figures 41 and 42, though not to the same extent. (Because of the boat dynamics during the last half of the two leg 2s, the noise on channel 32 during these periods is spread over the full range of speeds in the upper portion of figure 43 which includes both cycles; similar effects are seen in figures 44 through 46.)

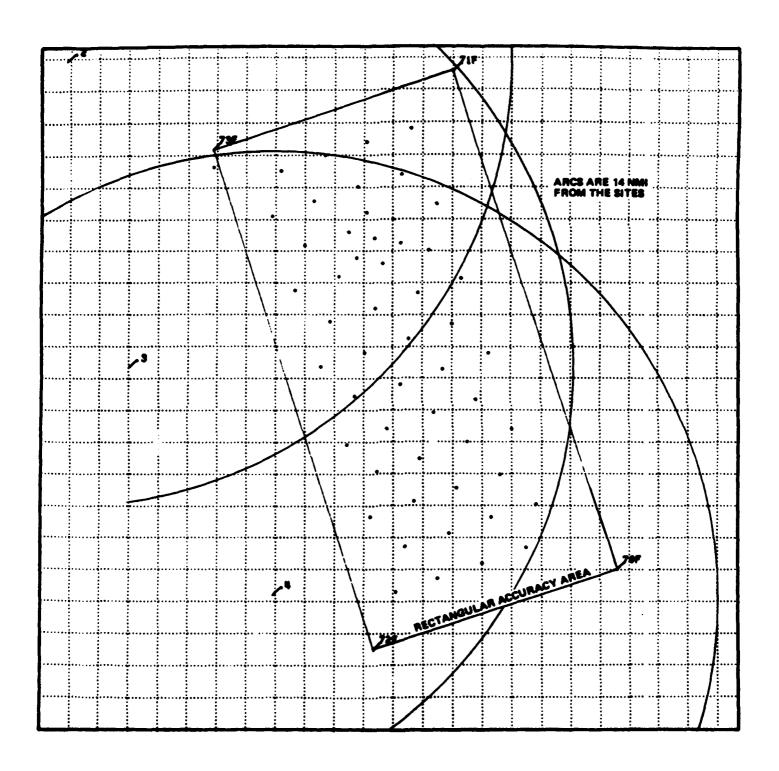
Figure 47. Rectangular accuracy area.

Figure 47 depicts AUTEC'S WR and STS geometry. The rectangular area shows the area over which STS tracking accuracy requirements were applicable during the SAT. The STS downrange sites are located at AUTEC sites 2, 3, and 4. Range limits of 14 nmi from each of the sites are shown in figure 47. The STS's ability to track out to the required 14 nmi from each site was demonstrated during the Maximum Range Test (MRT) of the SAT. The system should not be committed to track beyond 14 nmi without additional on-range testing. Insufficient data were collected during the SAT to relate maximum range to sea state, but a 14 nmi maximum range for seas up to 3 feet is believed to be a safe commitment.

As can be seen in figure 47, about 35 percent of the rectangular accuracy region is within the STSs three-site coverage area, as defined by the 14 nmi arcs. Most of this three-site coverage is in W3. Note that the 14 nmi range limit leaves a triangular area (of about 6 square nmi) in the southeast corner of the rectangular accuracy area where the STS cannot track sonobuoys. This region is just outside the 427 array, the WR's most southeasterly hydrophone array.

For the most part, these azimuth limits bound angles subtended at each site by the accuracy rectangle shown in figure 47. In the case of site 2, its smaller azimuth limit was decreased from 92 to 80° to satisfy a requirement originally imposed with the idea of extending tracking north of the WR a few miles.

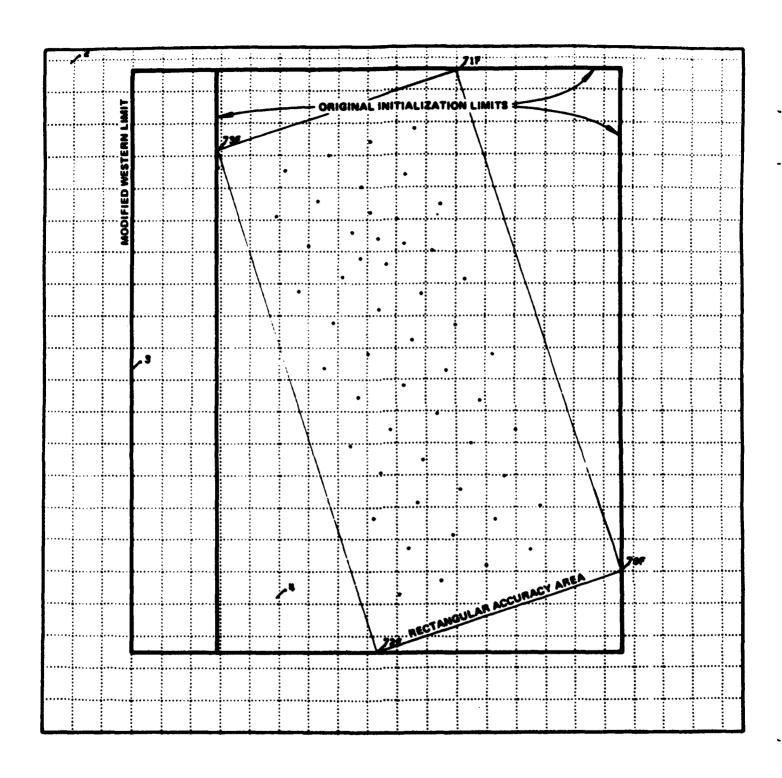
Figure 48. Tracking initialization limits.

In addition to the limits on tracking already mentioned, limits were also placed by vendor on tracking initialization. Tracking initialization is accomplished through a series of iterative least squares adjustments whose results must pass certain criteria before the track is handed to the Kalmar filter. Solution limits during initialization are in the form of minimum and maximum X and Y coordinates which establish a rectangle, the sides of which run N-S and E-W. The STS vendor arranged this initialization limit box to circumscribe the rectangular accuracy area as shown in figure 48.

Once track has been initialized and handed over to the Kalman, the initialization limits no longer apply. Therefore, tracking which originated within the initialization limit box can continue beyond its boundaries (to the extent of the other limits already discussed), and this tracking was verified (500 yards across the northern limit) during the SAT (demonstration 1). However, if loss of track occurs while the transmitter is beyond this limit box, reinitialization cannot occur (beyond the limit).

That the initialization limit box could be opened up without deleterious effect on initialization or tracking was verified during the SAT (demonstration 3) by temporarily expanding the box by 20,000 meters (10.8 nmi) on all sides. In October 1990, well after the SAT, the western boundary of the rectangle (minimum value of WR coordinate X) was moved west from -80 meters to -5,000 meters to permit initialization track further west (see figure 48). It is understood that the western boundary remains at this location; it has caused no tracking difficulty.

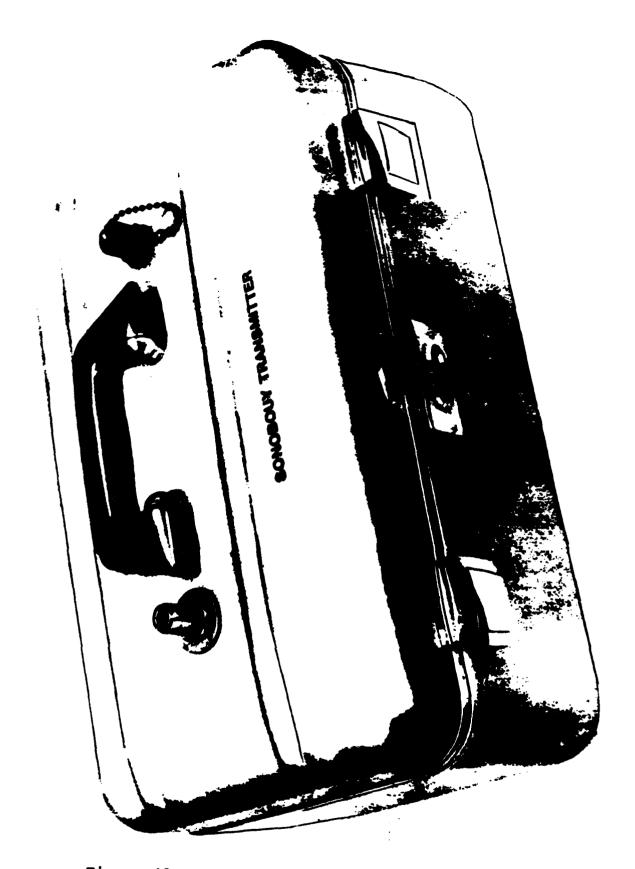
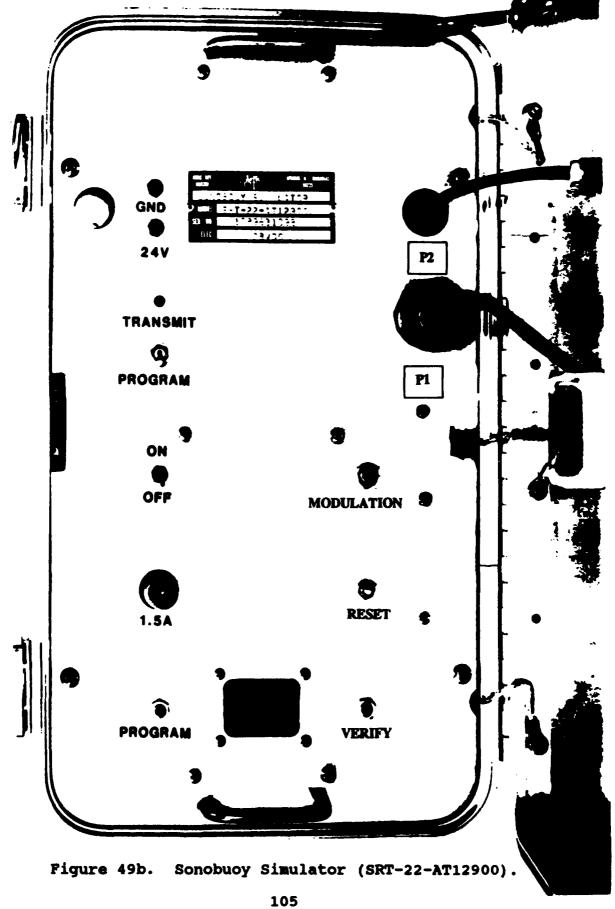
Figure 49a. Sonobuoy Simulator (SRT-22-AT12900).

Based on the 31 July 1990 post-SAT test, the 22 October 1990 OAT and the 26 February 1991 post-OAT test, the AUTEC-produced portable sonobuoy simulators (SRT-22s) (see figures 49a and b), have performed well aboard AUTEC TRs when their antennas were properly located as high and as unobstructed as possible and definitely above the wheelhouse roof and above other broad metallic structures.

- (1) The SRT-22s reliability for long-term use is questionable.
- (2) Reliability is certainly not enhanced when the antenna is not tuned to the selected transmit frequency.

(Reflected power has been observed to be as high as 25 percent of transmitted power.)

(3) If run until scuttle time, the scuttle sequence can destroy the unit. If turned off before this time and restarted, there is at least a 17-second delay before transmission can resume.

If the STS is to be routinely used to track boats on the WR, a more permanent sonobuoy simulator transmitter should be considered. Further, a more permanent installation aboard the TRs would seem warranted, perhaps including a coaxial switch for less wear and tear on coaxial connectors when the trombones are switched from one use to another (voice-communication versus STS).

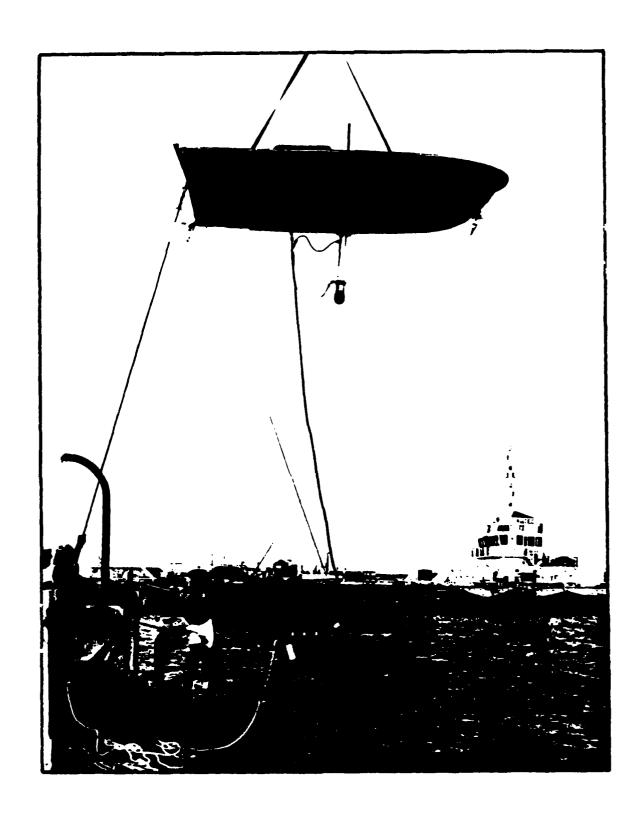
Figure 51. Sonobuoy simulator vehicle as modified by AUTEC.

The SSV tow-cable faults experienced during the calibration exercises have been repaired. Range engineering have no schematics for the SSV electronics at this time, but this information has been requested through channels.
